6.0 Grand Junction, Colorado, Disposal Site

The Grand Junction, Colorado, Disposal Site, inspected on April 4, 2007, is in good condition. A portion of the disposal cell remains open and is operated by DOE to receive additional low-level radioactive waste materials from various sources. The annual inspection requirement is only applicable to the closed and completed portion of the disposal cell and surrounding disposal site.

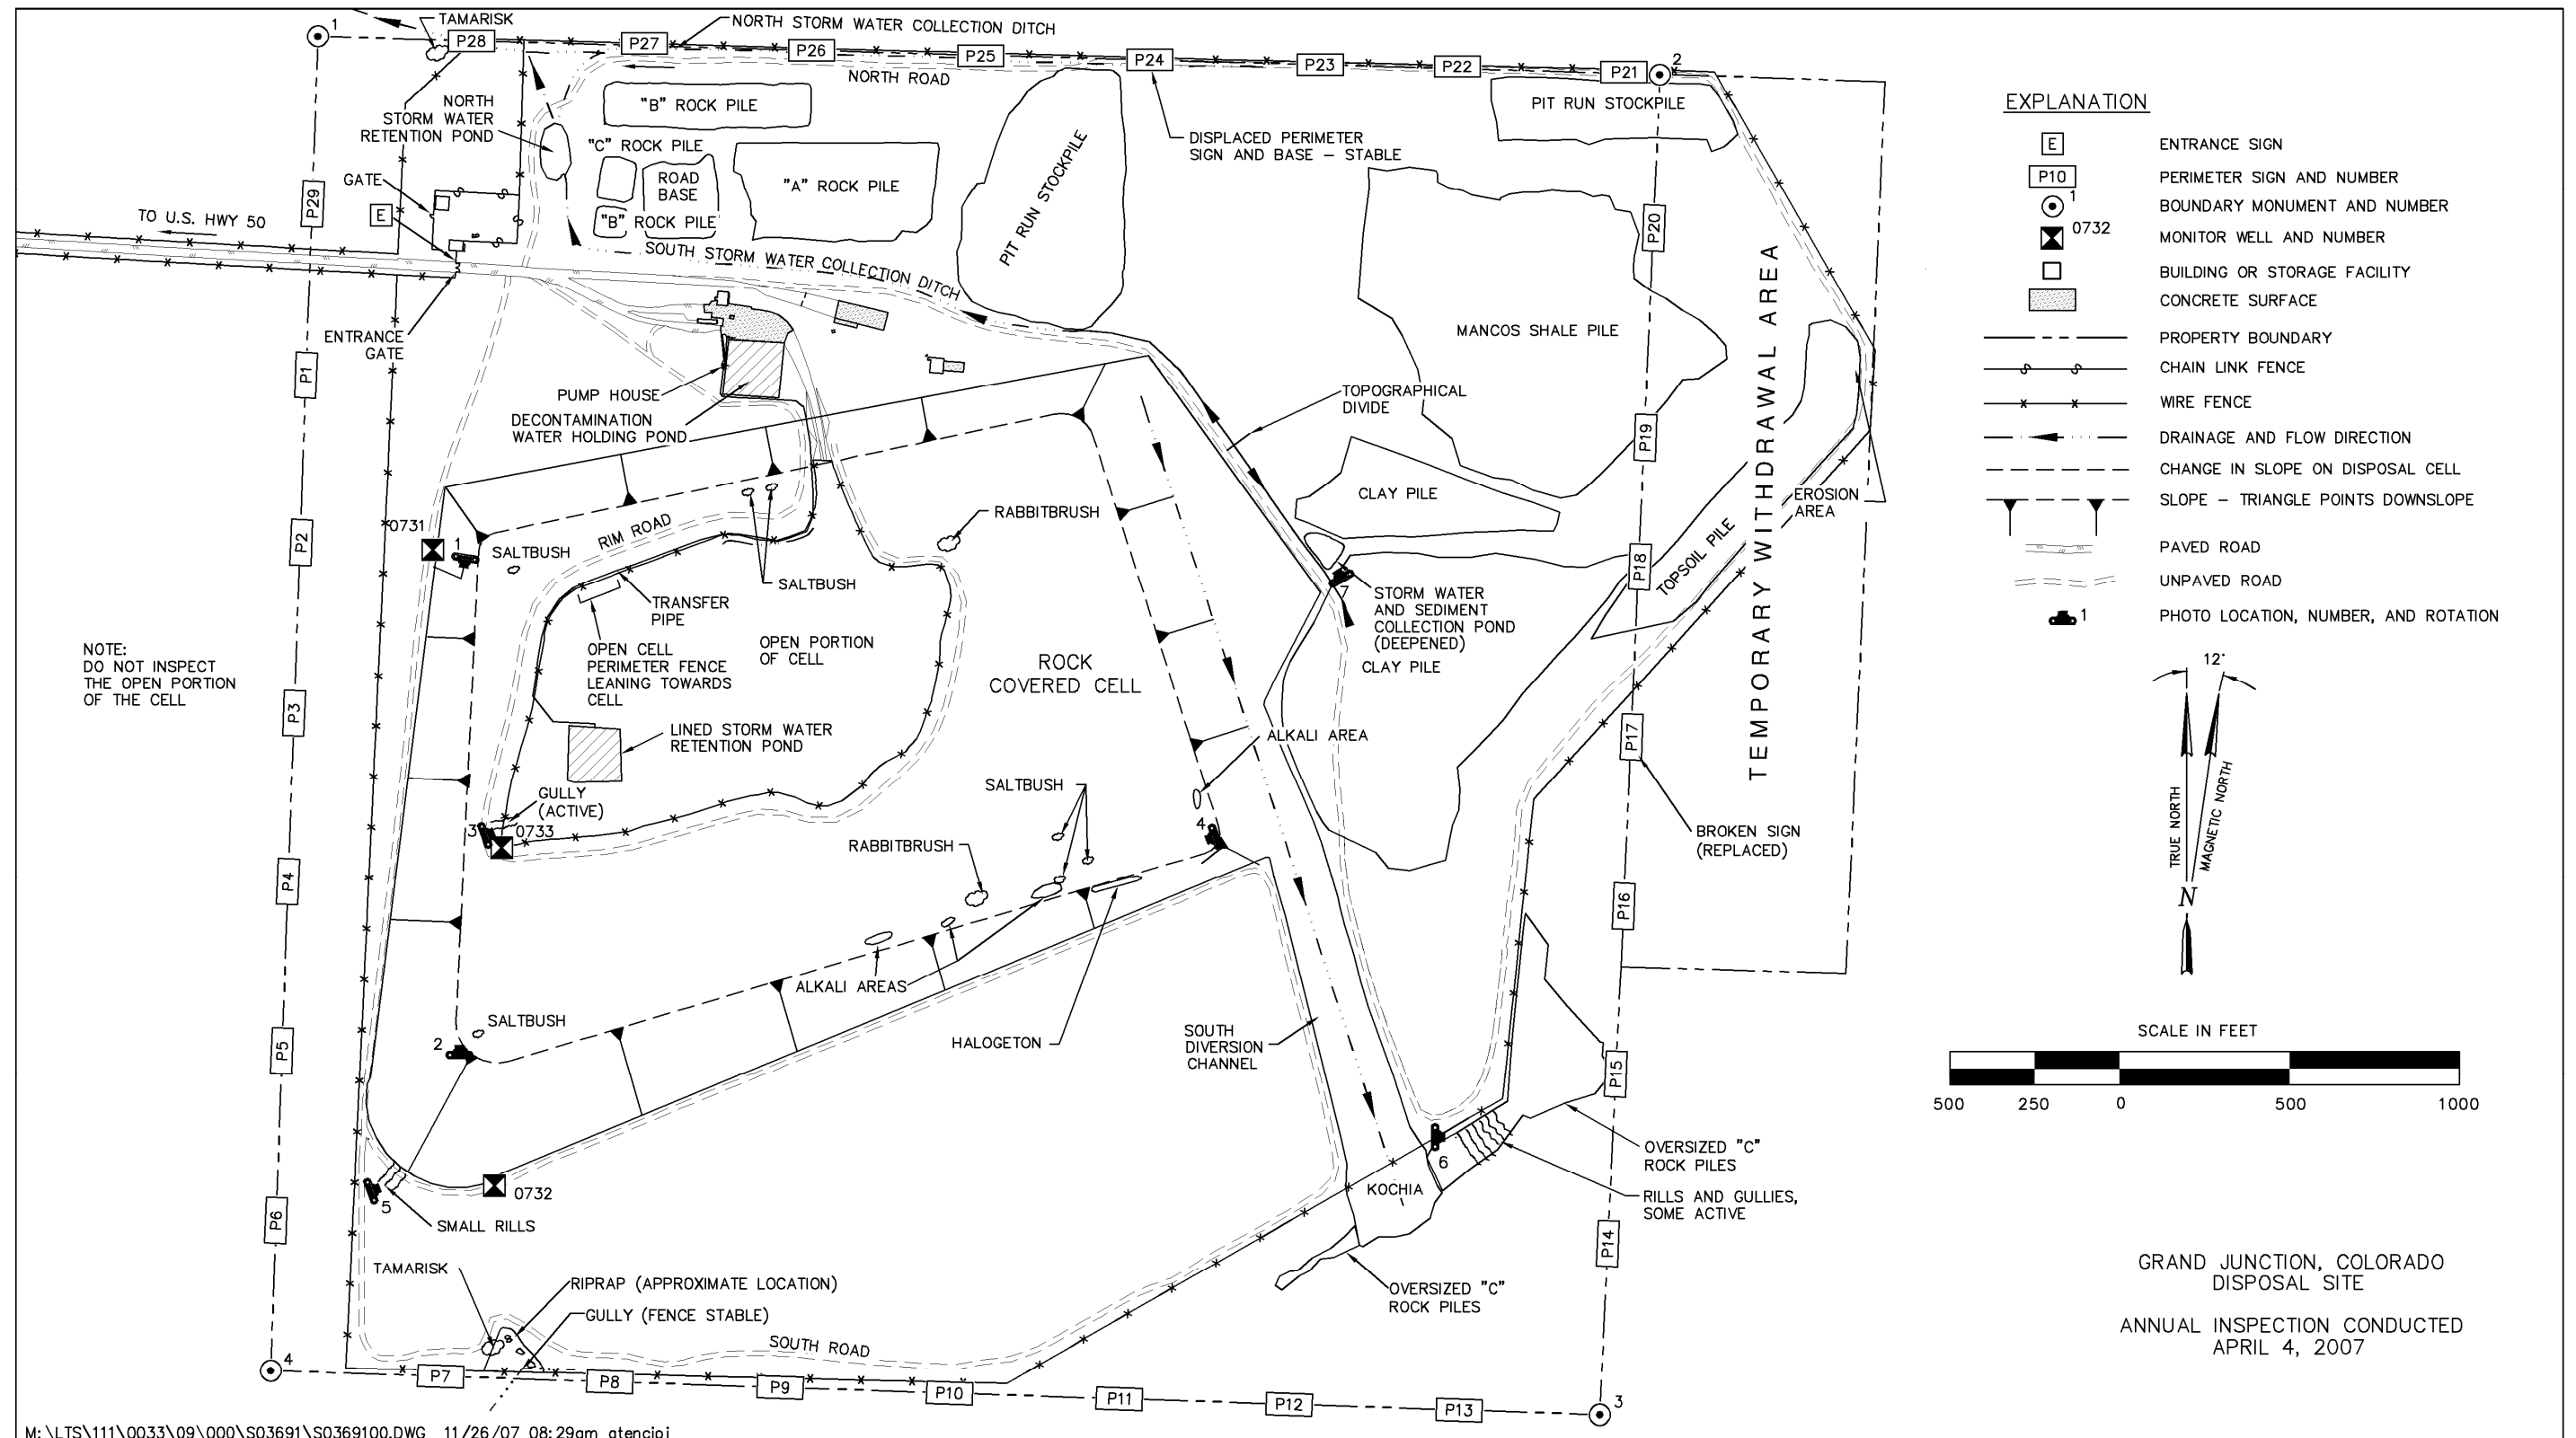
Figure 6-1. 2007 Annual Compliance Drawing for the Grand Junction, Colorado, Disposal Site

Site Access Gate, Access Road, Entrance Gate and Fence—Access to the site is controlled by two double swing stock gates, one in the U.S. Highway 50 right-of-way fence and a second 1.7 miles east at the site entrance. The DOE locks, chains, and gates were in excellent condition.

Entrance and Perimeter Signs— An entrance sign is located at the entrance gate, and 29 perimeter signs are located at regular intervals along the DOE property boundary. The signs are installed on galvanized steel posts set in concrete. Perimeter sign P17 was found damaged and replaced. Several signs are slightly bent or warped but are legible. All of the other signs are in excellent condition. The base of perimeter sign P24 had been slightly displaced when hit by road grading equipment but is stable.

The site has four permanent boundary monuments, one at each of the four corners. The monuments mark the exact location of the site corners. All were in excellent condition.

Monitor Wells—The groundwater-monitoring network consists of three monitor wells. All three wells are inside the site boundary. The wells were secure and in excellent condition.

Closed Portion of the Disposal Cell—The top and side slopes of the disposal cell are covered with basalt riprap. The rock is durable and in excellent condition. There is no evidence of slope instability and very little plant encroachment is occurring on the side slopes (PL-1 and PL-2).

- 6B** A small gully has formed on the disposal cell cover that drains and is mobilizing a minor amount of sediment onto the southwest slope of the open cell area (PL-3). This location was repaired to prevent further erosion into the open portion of the cell.

Severe rainstorm events during fall 2006 apparently caused the cell apron (a rock-filled trench) to overflow at the southwest corner of the disposal cell. Several small rills developed across the apron perimeter road (PL-5), but are insignificant and do not require repair at this time.

- The gully on the southwest slope of the open portion of the cell was repaired to prevent further erosion.
